Phasecon Mining

Our Revolutionary Retort Tube

Unlocking Efficiency

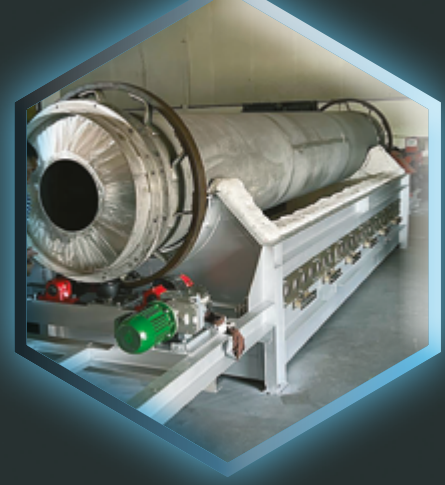
At Phasecon Mining, a division of PHM Global, we're dedicated to pushing the boundaries of efficiency and innovation in industrial processing. Our latest breakthrough - the revolutionary Retort Tube - is poised to redefine the standards of **heat transfer technology**.

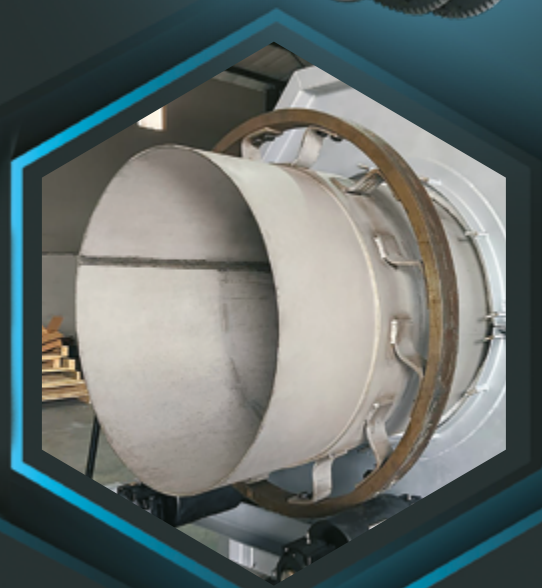
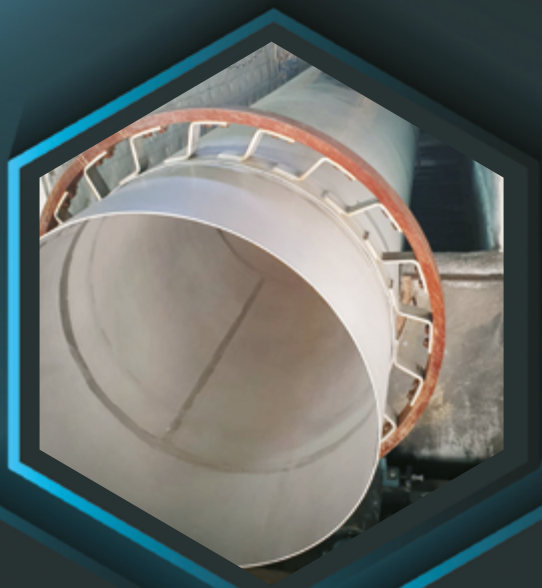
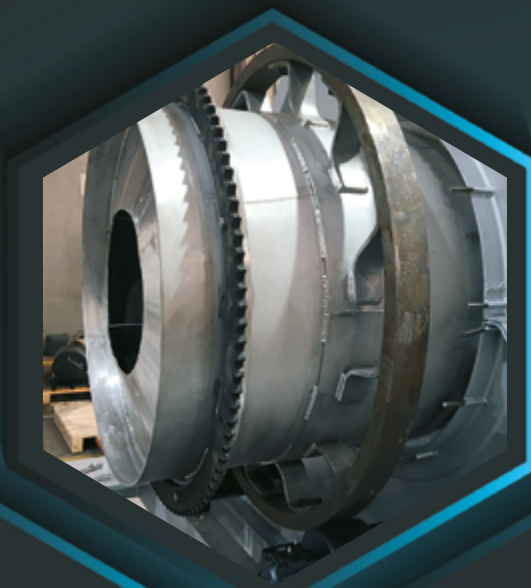
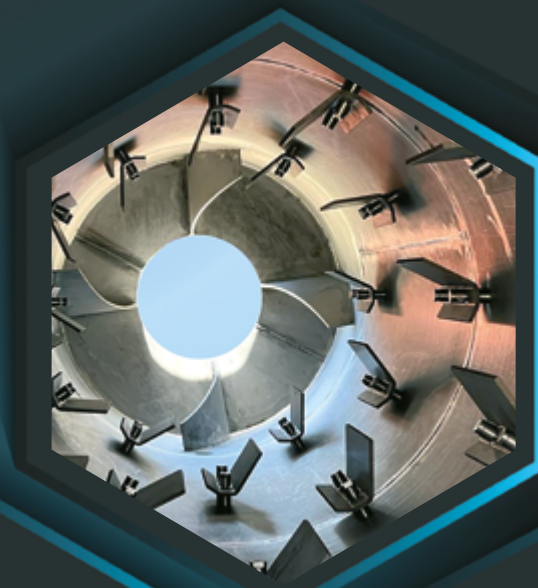
Phasecon Mining's retort tubes feature a barrel section, geared head section, and two support rings. The head section seals against the screw feeder hopper interface plate, with drive sprockets and support riding rings bolted on for easy replacement.

Our design allows for lifters inside the tube to **optimise carbon mixing** and **ensure sufficient contact time** with the tube wall for heat transfer.

With **specially designed lifters** that magnify surface contact, our retort tube maximizes heat transfer efficiency, ensuring uniform heating and unmatched performance.

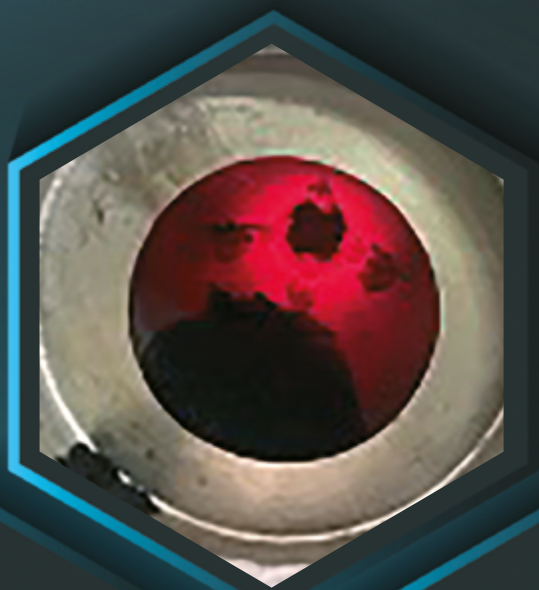
COMMON CAUSES OF RETORT TUBE FAILURES

1. Material Selection: The choice of material significantly impacts the performance and longevity of retort tubes. Improper material selection can lead to corrosion, deformation, and structural failures.

2. Front Seal Plate Failure: Incorrect installation and inadequate clearances between surfaces can cause front seal plate failure, resulting in leaks and efficiency loss.

The front interface seal plate on a retort tube can fail if the screw feeder interface seal plate is incorrectly installed, leading to insufficient clearances between these surfaces.

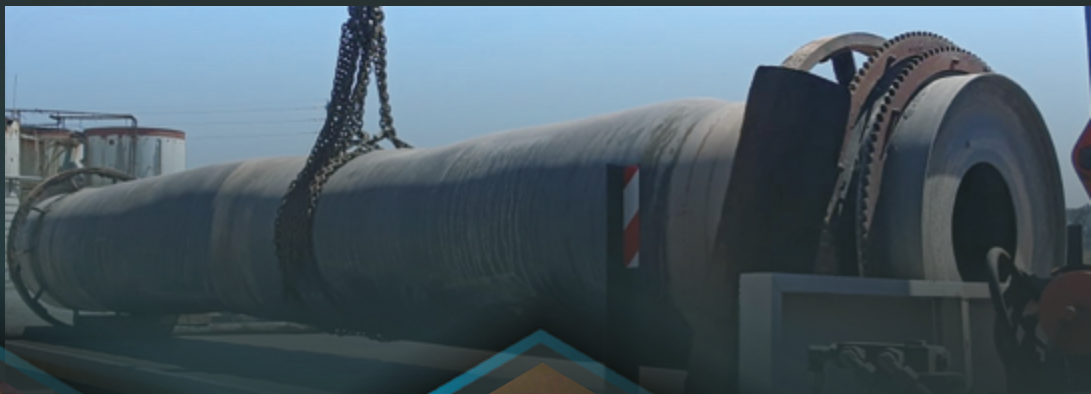
3. Seal Plate Welding Failure: Carbon abrasion due to continuous feed into the retort tube can lead to welding surface wear and eventual failure over time.

4. Retort Tube Rupture: Overload conditions, thermal stress, and inadequate material strength can contribute to retort tube rupture, posing safety risks and production downtime. Rupture strength is the stress required to cause rupture under specified environmental conditions. Creep rupture, or stress rupture, is the process where a material under a constant high load creeps to failure. Creep failure happens when accumulated creep strain causes deformation beyond design limits.

5. Retort Tube Deformation: caused by over-temperature conditions, thermal shock from water ingress, overloading due to blocked discharge chutes, and uncontrolled heating.

6. Riding Ring Supports - Spokes Failure: The spokes could fail due to welding issues or loose bolts during operation.
